**SUBJECT:** A machine operator died when caught in a plastic injection molding machine.

**SUMMARY**  
**California FACE Report #03CA004**

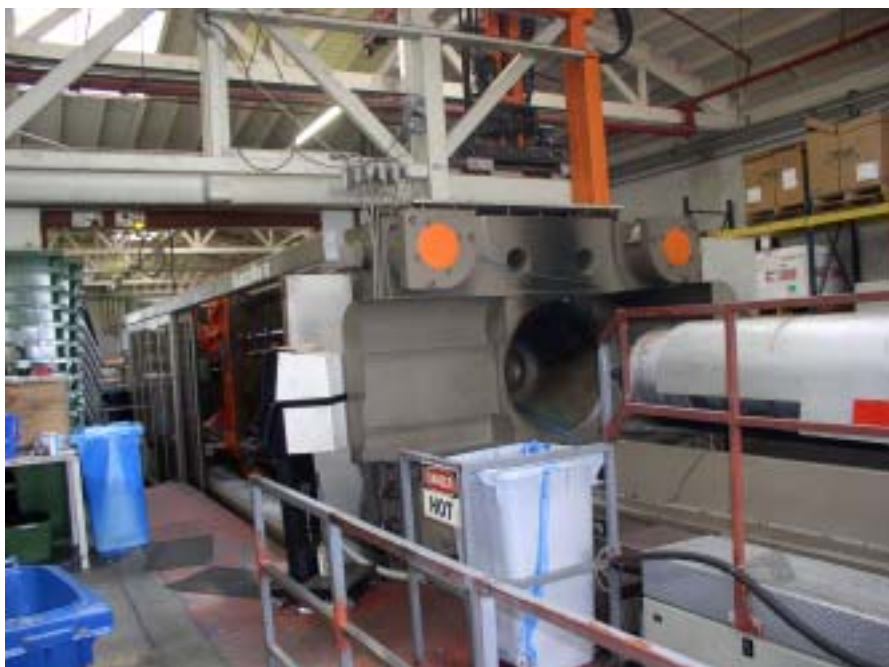
Exhibit #1

View of the plastic injector mold involved in this incident.

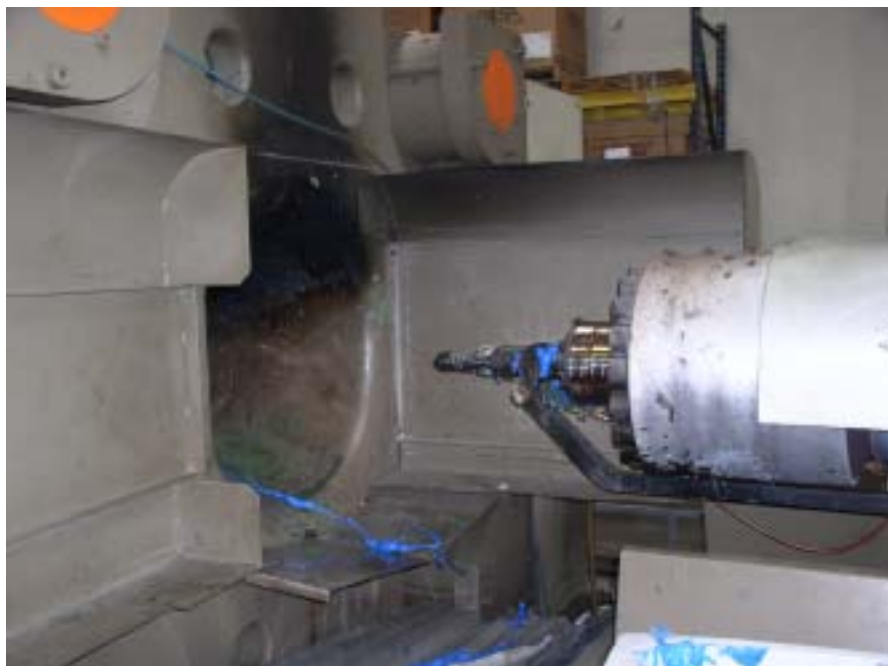
Exhibit #2

View of the area where the victim was caught.

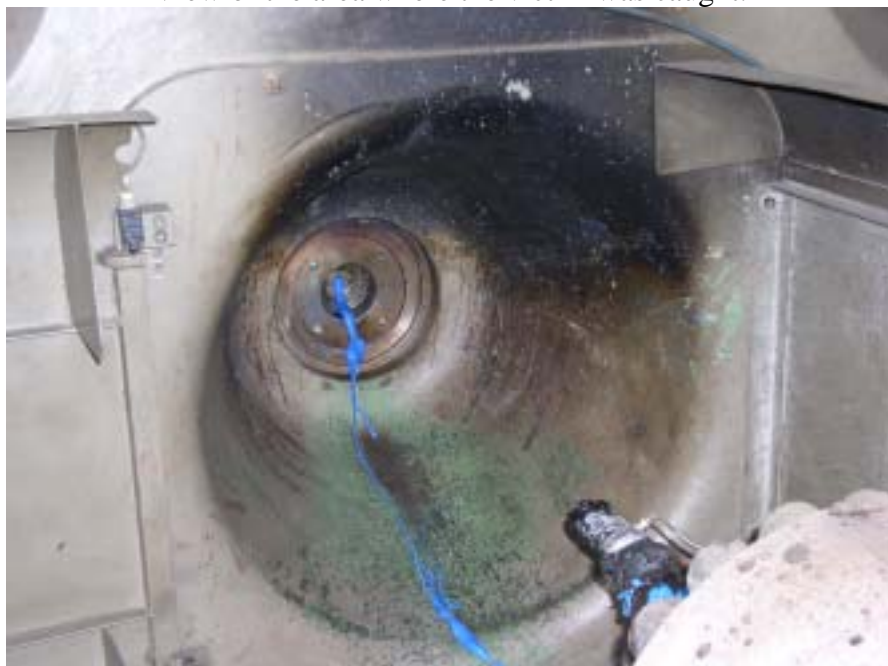
Exhibit #3

Closer view of the area where the victim was caught.

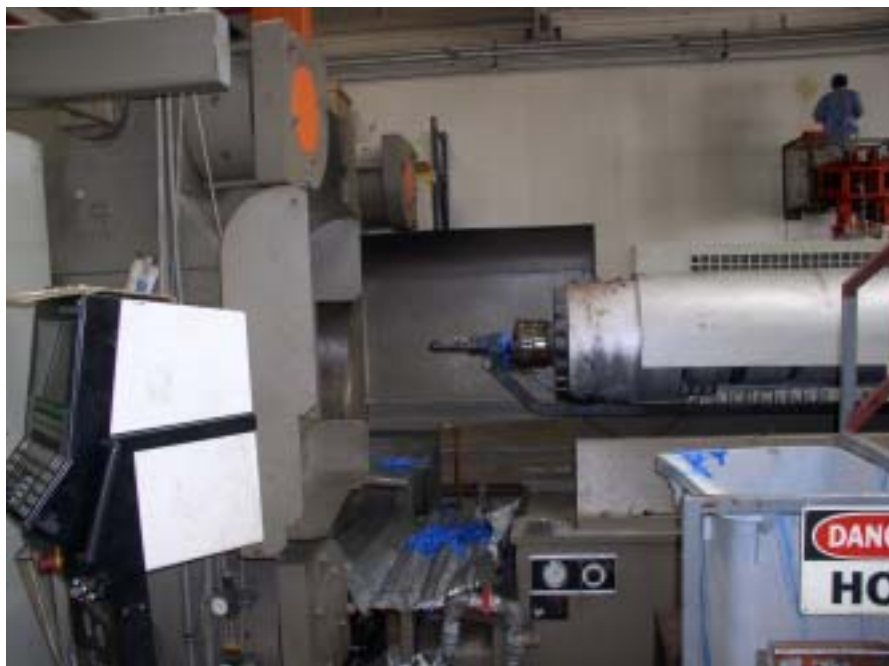
Exhibit #4

View of the injector with the protective shield open.

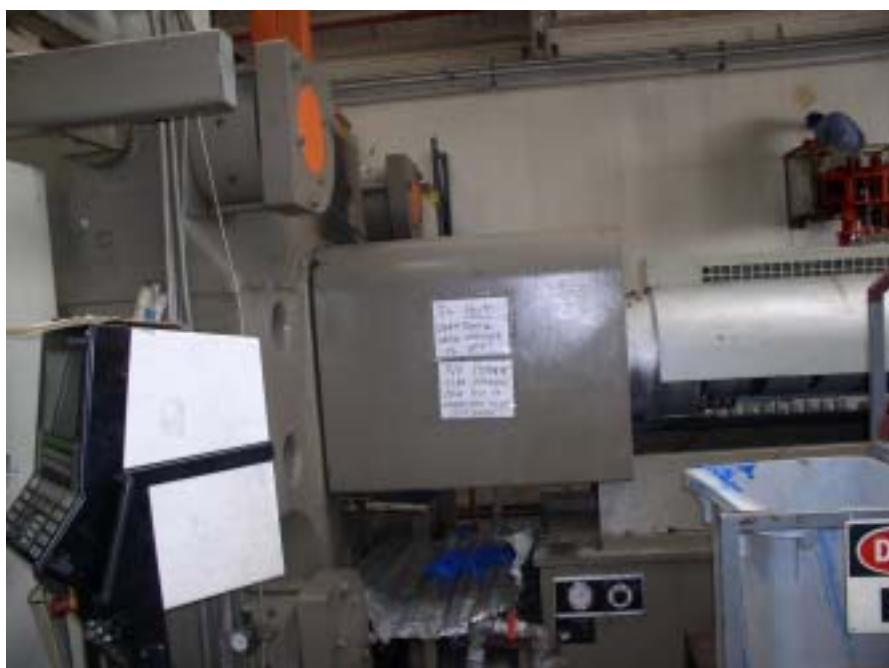
Exhibit #5

View of the injector mold with protective shield in place.

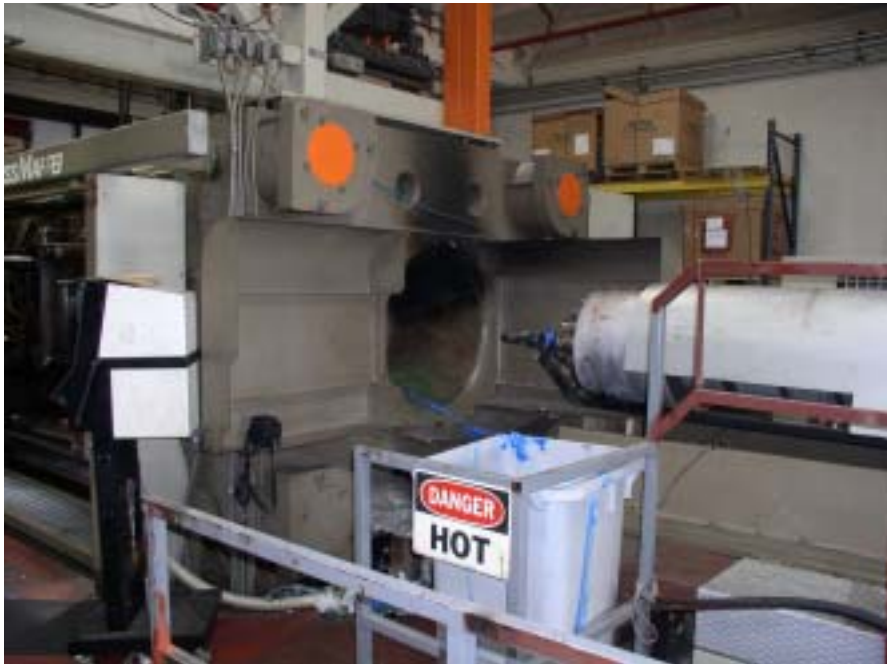
Exhibit #6

The site of the incident was a manufacturing plant of plastic products for home, office and industrial use. On the day of the incident, the victim was assigned to operate a plastic injection molding machine that was mostly automated. The machine involved in this incident covered an area approximately 80 feet long by 12 feet wide and 12 feet high (**exhibit #1**). The machine involved in the incident was molding high-density polyethylene plastic trash cans. The machine was made up of two components: an injector head and a mold frame. The end of the mold frame had a concave cone-shaped opening with a machined seat in the center (**exhibits #4 & 5**). The injector head end was round and mated with the mold seat. The area where these two sections met had a two-piece metal shield. The back portion of the shield was fixed parallel to the injector (**exhibit #3**). The front side of the shield was hinged to allow access to the junction between the mold and the injector for maintenance (**exhibit #2**). The hinged shield was equipped with an interlock safety switch which was supposed to shut down the machine when open (**exhibit #6**). The safety interlock was not working at the time of the incident.

View of the injector mold that injects the heated plastic into the mold.

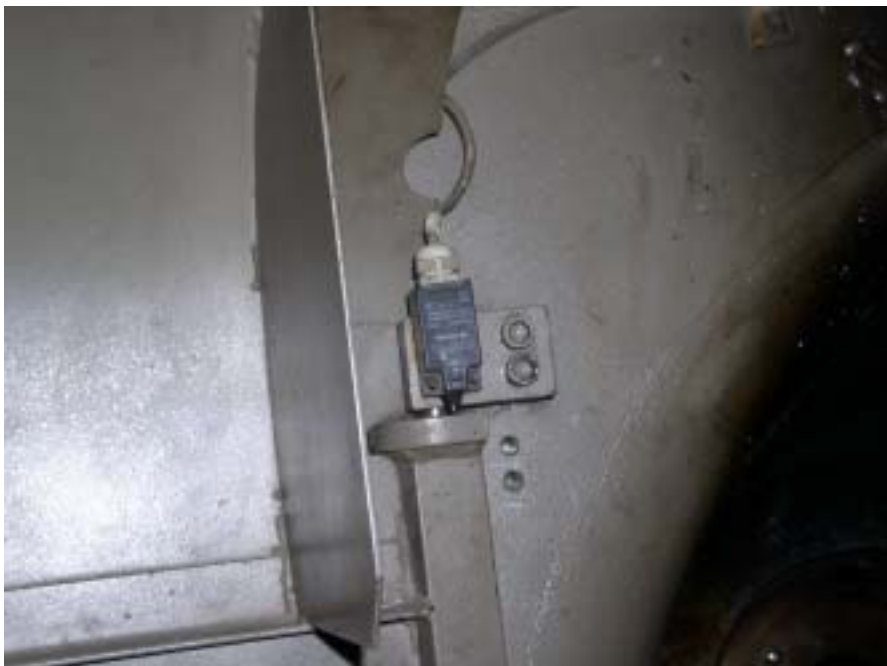
Exhibit #7

Discussion: The machine involved in this incident had a safety interlock device attached to the front side hinged metal shield. This device should have automatically shut off the machine when the victim opened the hinged shield to gain access to the injector. This device was non-operative. Safety devices should be checked daily to assure their working order. A log should also be kept documenting these daily checks. Workers should not be allowed to operate machines that have identified hazards such as disabled or inoperative safety interlock devices. Had this machine been properly maintained or removed from service until maintenance was completed, this incident might have been prevented.

View of the safety switch that cuts the power to the machine when the door is open.

#### **Recommendation #2: Ensure all machine safety interlock devices are in working condition.**

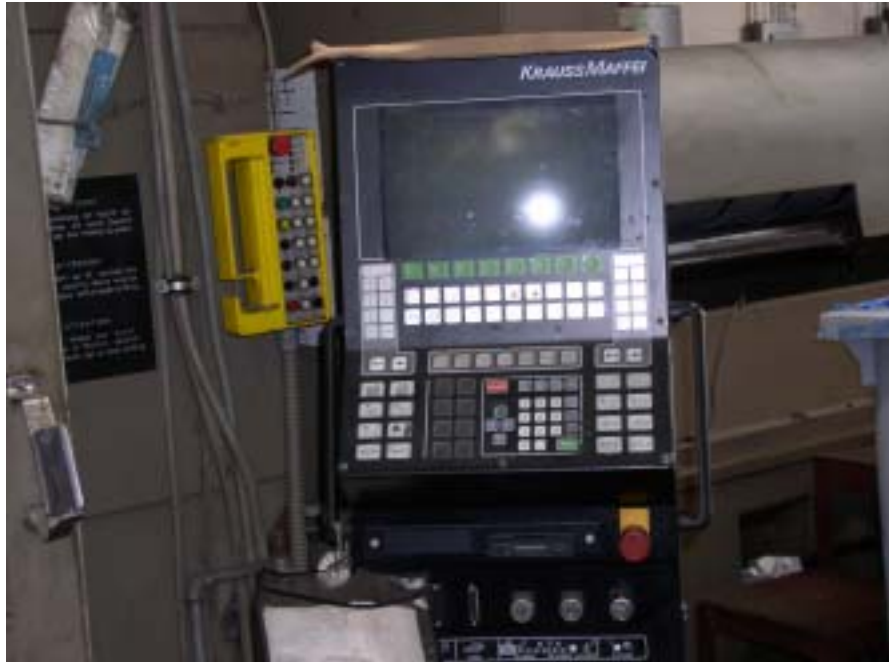
Exhibit #8

View of the control panel for the machine.
